HUNTINGDON SMITHFIELD DAM

(NDI I.D. PA-00511)

PHASE I INSPECTION REPORT,
NATIONAL DAM INSPECTION PROGRAM

PHASE I REPORT
NATIONAL DAM INSPECTION PROGRAM

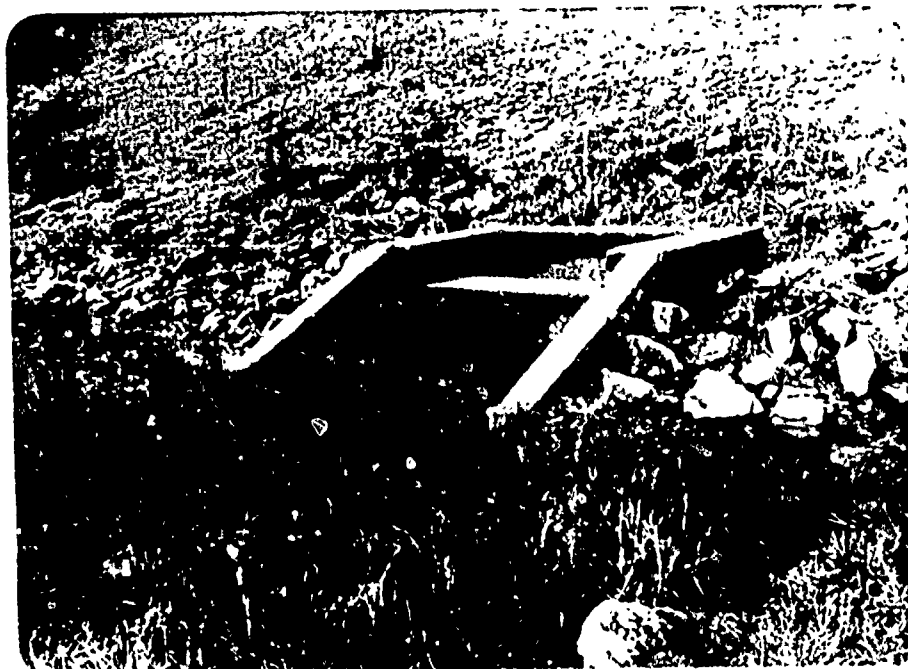
Photograph No. 3
Outlet pipe discharge structure.

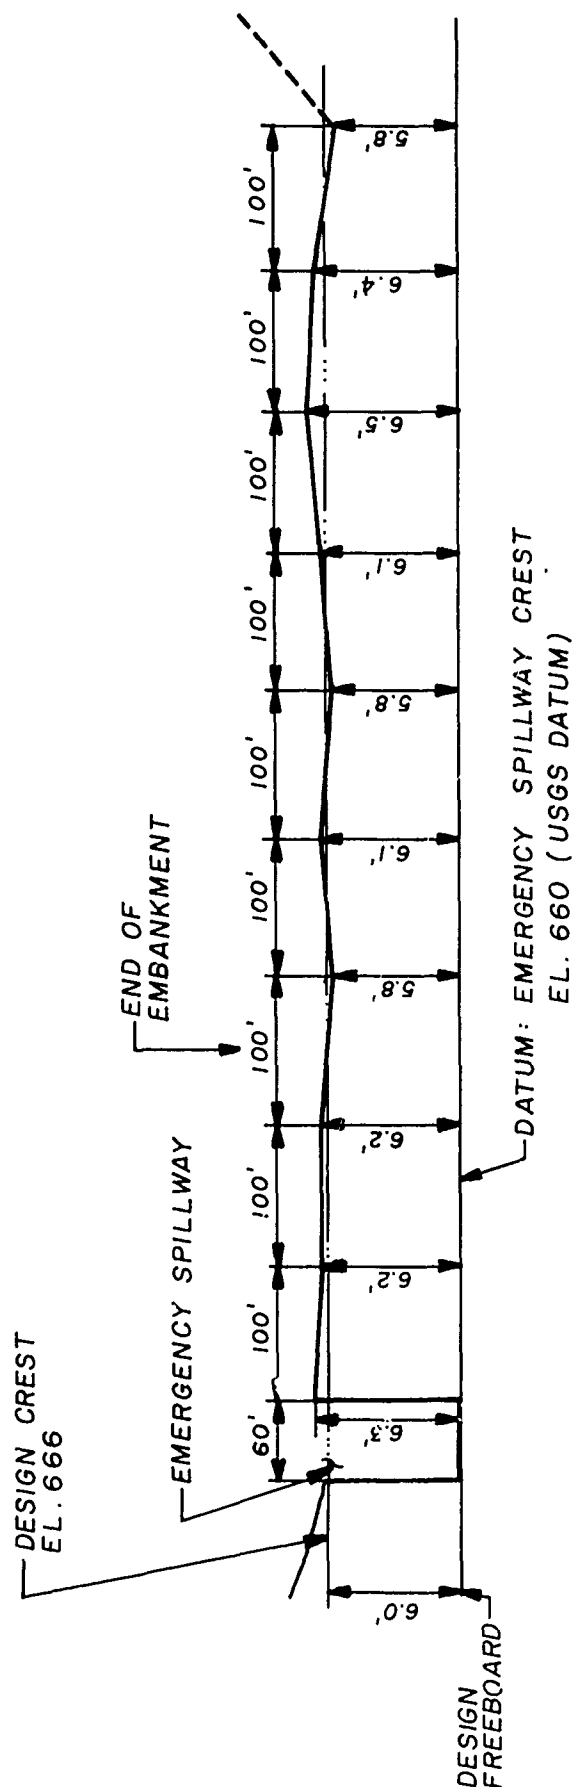
DAM CREST PROFILE (LOOKING DOWNSTREAM)

In general, the condition of the dam is considered to be good. The crest of the dam was surveyed relative to the emergency spillway crest elevation and it was found to be generally at the design crest elevation. The dam crest profile is illustrated in Plate 7. The downstream and upstream slopes were surveyed and found to be reasonably within the design slopes of 2H to 1V on the upper half of the embankment and 3H to 1V on the lower half of the embankment.

VISUAL EXAMINATION OF	OBSERVATIONS	REMARKS OR RECOMMENDATIONS
SURFACE CRACKS	None	
UNUSUAL MOVEMENT OR CRACKING AT OR BEYOND THE TOE	None	
SLOUCHING OR EROSION OF EMBANKMENT AND ABUTMENT SLOPES	None	
VERTICAL AND HORIZONTAL ALIGNMENT OF THE CREST	See Plate 7 for the longitudinal dam crest profile.	
RIPRAP FAILURES	None
